Air10™ Series HumidAir™ Tub Discoloration

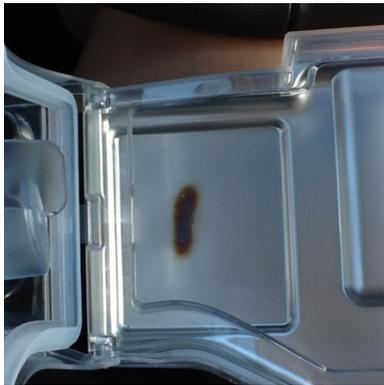
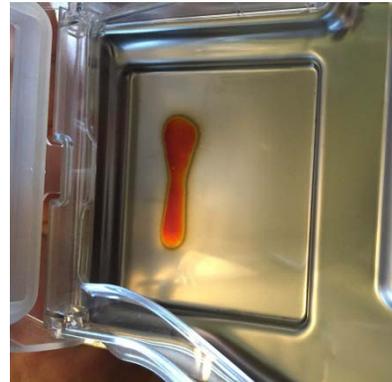
HumidAir Tub Discoloration Examples

We have received reports of discoloration or staining appearing on the metal surface inside of the HumidAir heated humidifier tubs used with Air10™ devices. As a medical device manufacturer, ResMed values all feedback on the performance of our products and services. This feedback is critical to ensuring patient safety and product quality with our systems.

The discoloration presents no risk to the patient or their therapy. Additionally, the discoloration does not impact the functionality or useful life of the tub as our extensive investigation confirms the humidifier heating plate and circuitry of the device are working to design specifications.

The manufacturing process used to create the polished finish of the metal surface inside the tub results in slight variations of flatness that make some units more prone to discoloration when combined with the following factors:

- Higher temperature increases across the base of the tub due to the use of higher humidification levels or Climate Control Auto in environments with cooler ambient temperatures.
- Distilled water (contains fewer impurities, resulting in a higher likelihood of discoloration due to the interaction between the metal surface inside the tub and the water).

1. First wipe the discoloration with a cloth dampened with water.
2. Then wipe the discoloration using a cloth dampened with either lemon juice or a solution of one part household citric acid cleaner to 12 parts water.

3. Cover the metal surface inside the tub with the citric acid solution. Allow it to soak for 3 to 4 hours and then empty the citric acid solution from the tub. Wipe the discoloration using a cloth dampened with the citric acid solution.

4. Rub the stains with a cloth dipped in a paste made from lemon juice or the citric acid solution, and Cream of Tartar. The consistency of this paste should be similar to that of thick toothpaste.
5. Once the stains have been removed wash the tub using a mild detergent solution, rinsing thoroughly in water and then allowing it to dry out of direct sunlight and away from sources of heat.
